ERDC/CHL TR-01-26

## **Impacts of Navigation Channel Maintenance Dredging on the Coastal Processes of Chatham, Massachusetts**

Donald K. Stauble

September 2001

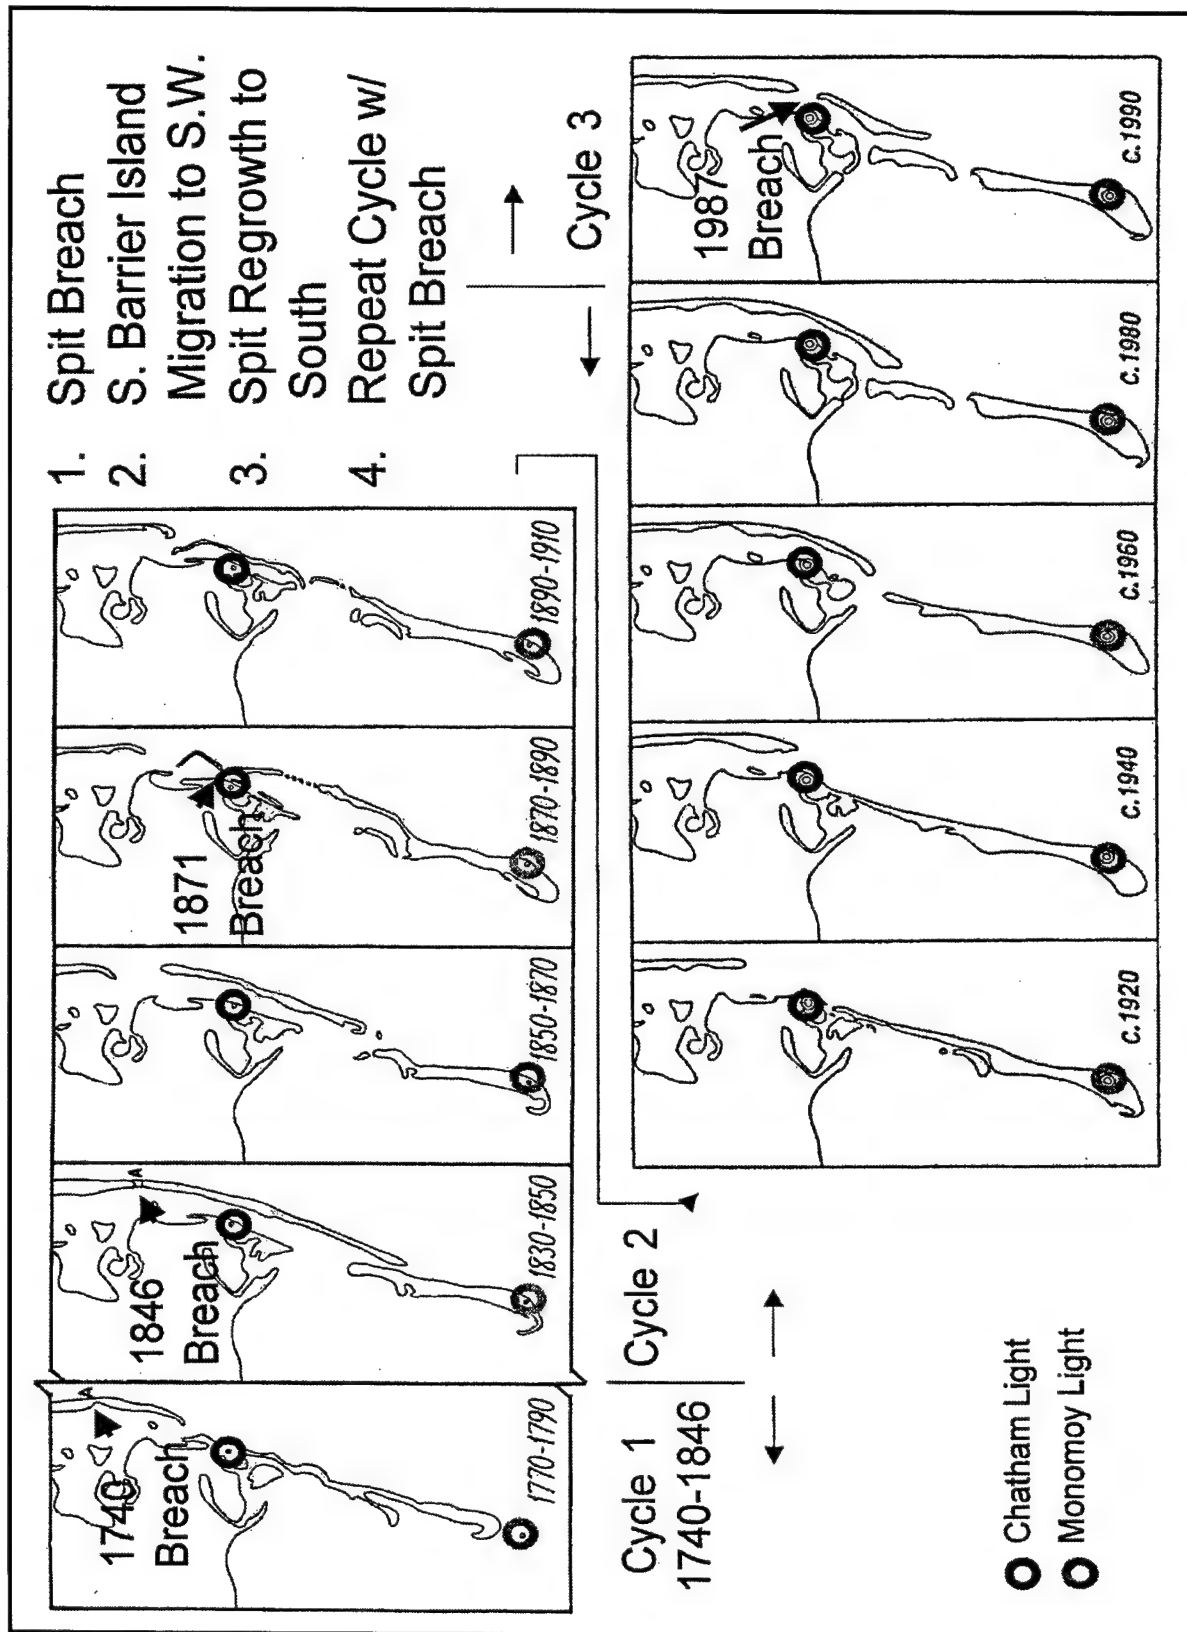
Figure 2. Cyclic change in Chatham shoreline since 1770s (after Giese 1988)

Historically, this barrier system has an approximate 140-year cycle of barrier spit growth and inlet formation (Giese 1988). The cycle starts with the growth of Nauset Spit southward from the mainland sea cliffs of Eastham and Wellfleet. The spit migrates southward with the prevailing longshore drift until a storm occurs and a breach breaks through a weak point in the barrier, creating a shortened spit and a detached barrier island from the southern portion of the spit. This southern barrier continues to migrate to the south and west and eventually welds to the mainland. Charts and other records dating back to the 1700s indicate that an inlet

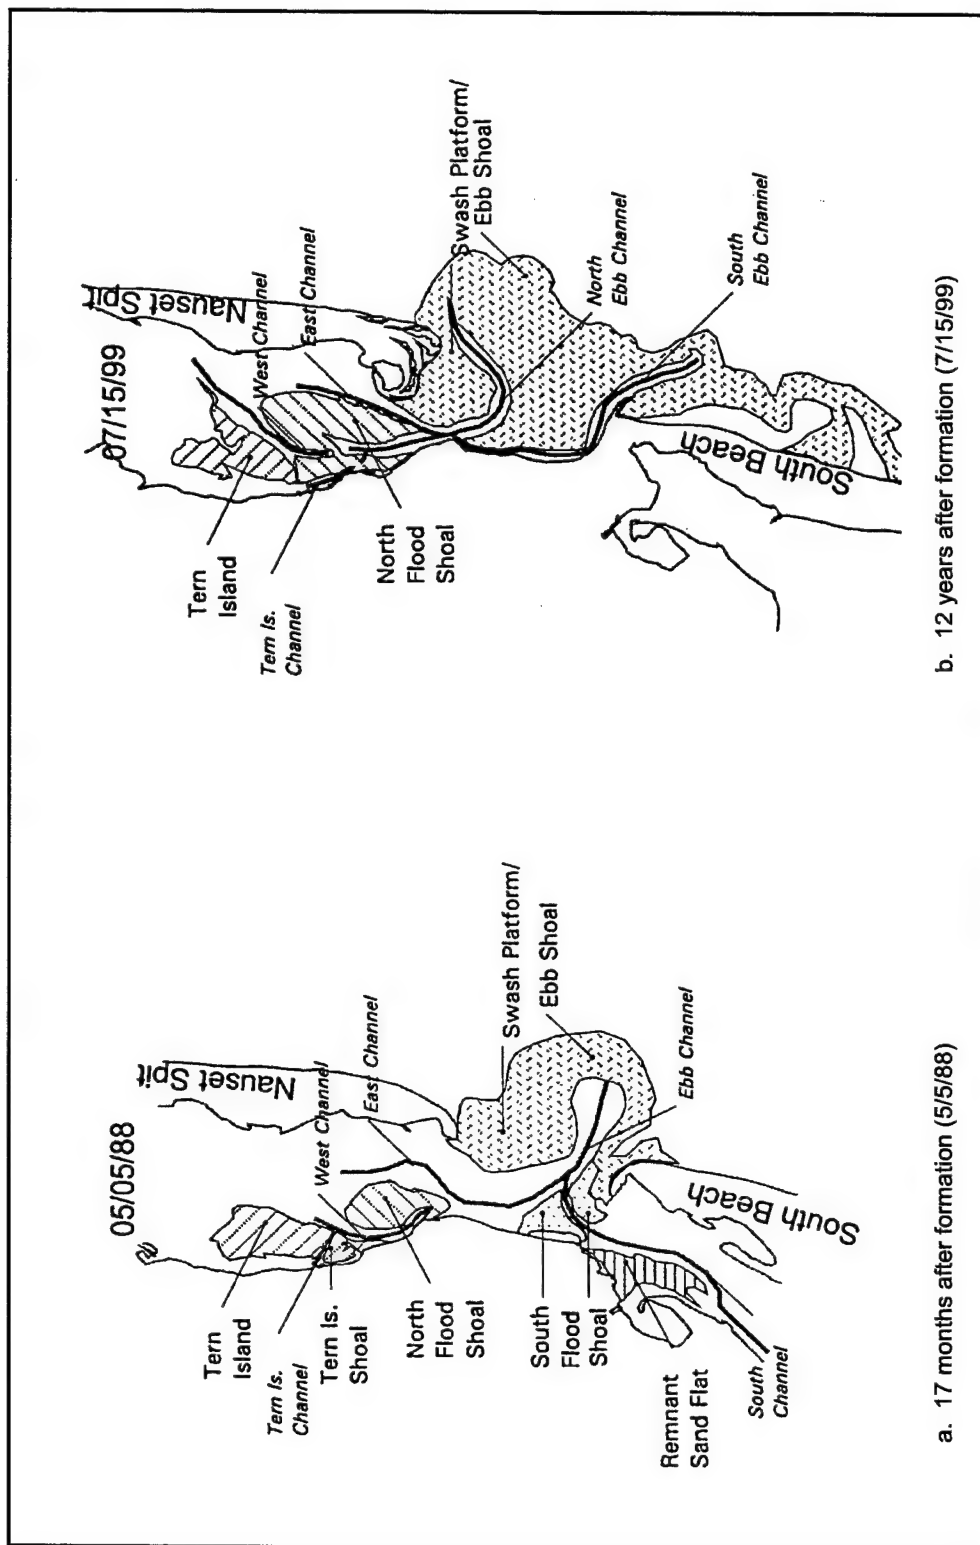
Figure 3. Morphologic features of the ebb and flood shoals, channel center line and shorelines associated with Chatham Inlet

Several shoals have been identified as the inlet has evolved and the number of shoals has changed as sediment has eroded and accreted with time. The outline of each shoal was digitized using the intertidal and subtidal boundary based on color change and bed forms visible on the photos. Water clarity is for the most part, good in this area, so the interface between the lighter color, shallow shoal and the

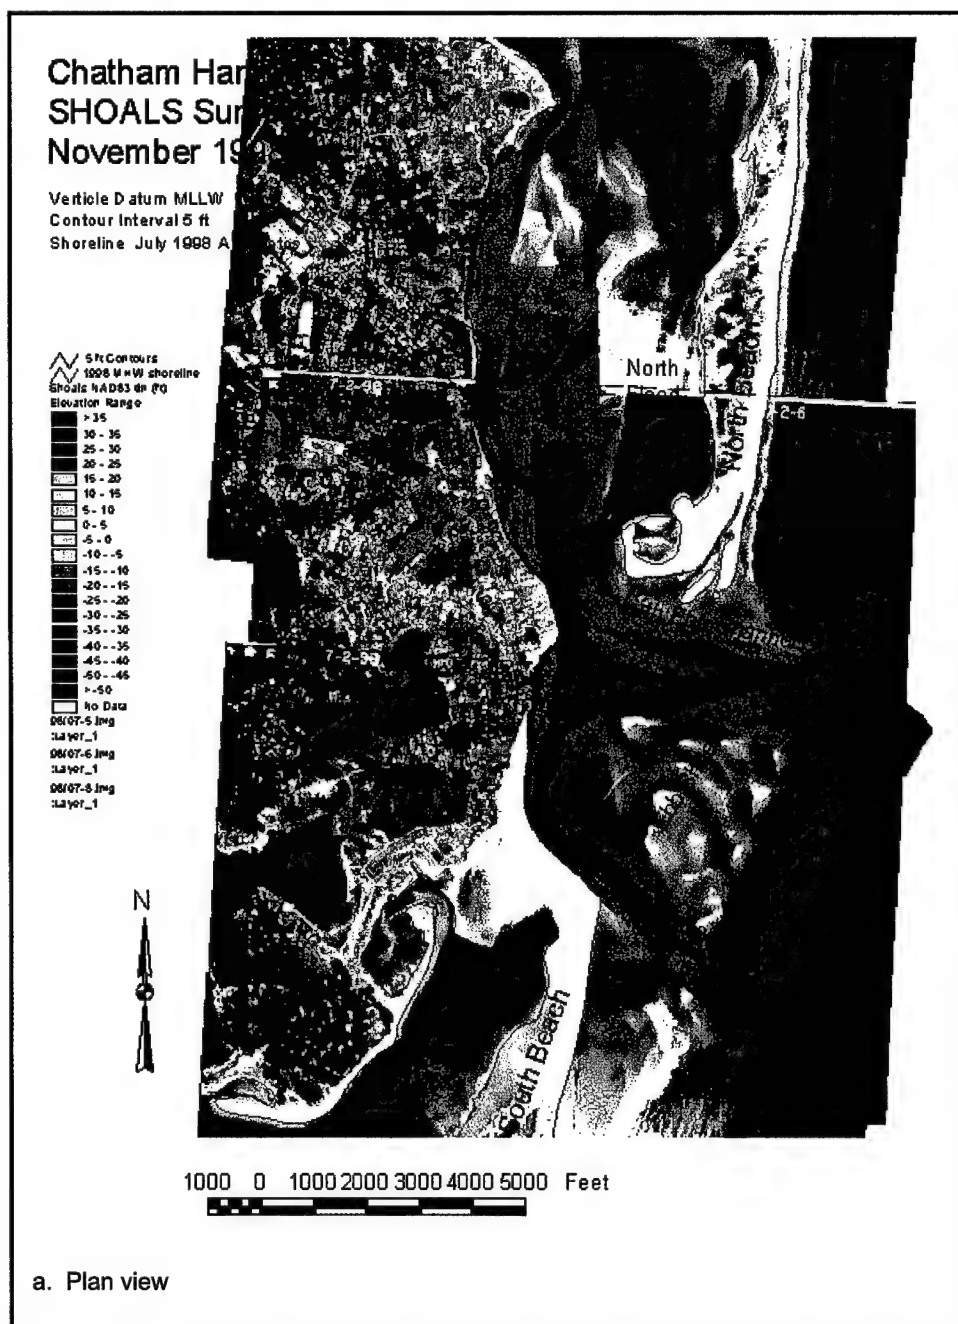
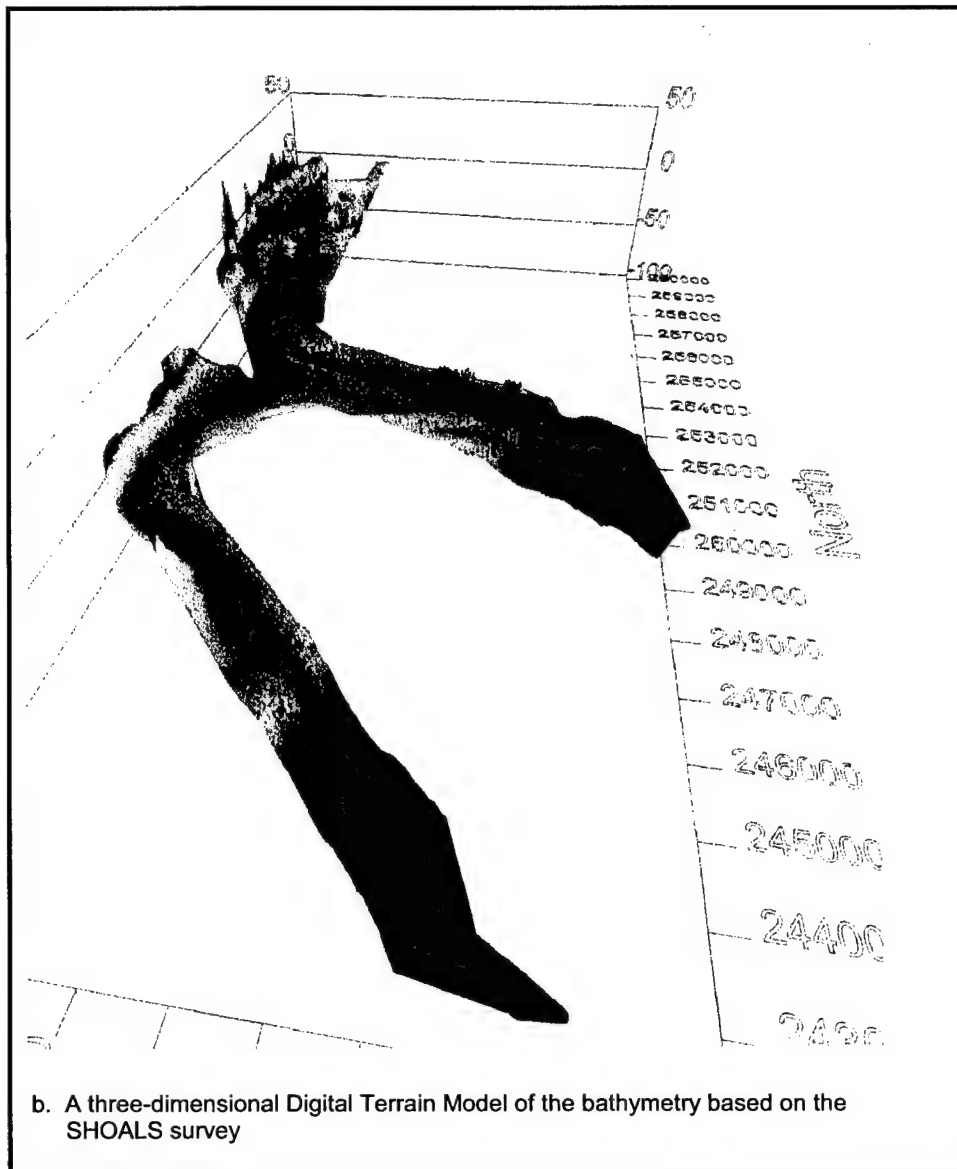
Figure 4. Bathymetry of portions of Chatham Inlet collected in November, 1987 by the SHOALS survey system (Continued)

Only one set of bathymetry was available for the area after the inlet was formed. A SHOALS survey was conducted in November 1998. The SHOALS system is described in Irish, Parson, and Lillycrop (1995). Due to limitations in the lidar system, the survey was limited to the ebb channels. Figure 4a shows a bathymetric map constructed from the SHOALS survey. The predominant south ebb channel and the incipient north channel are visible extending seaward through the ebb shoal as seen on a three-dimensional Digital Terrain Model (DTM) of the SHOALS data in Figure 4b. A large scour hole is prominent just to the bayside of the northern ebb channel. All depths are referenced to mean lower low water (mllw) on the SHOALS survey. Depths reaching to 29 ft (8.8 m) mllw in this scour area. The western side of the flood shoal is also visible showing the location of the west flood channel and the Tern Island channel. An ebb lobe is also present on the edge of the flood shoal where the west channel is trying to re-establish a continuous channel through the ebb shield on the western side of the flood shoal. A maximum depth of 54 ft (16.5 m) was recorded at the seaward end of the ebb shoal at the south ebb channel. Landward elevations reached a maximum height

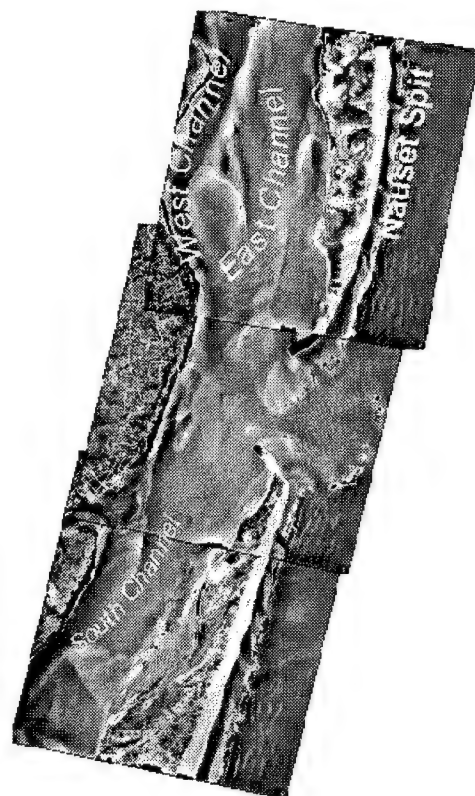
Figure 6. Postinlet morphology of Chatham Harbor, 7 May 1987

The first vertical aerial photography was flown five months after the breach, on 7 May 1987. Figure 6 shows the early stages of inlet development with the formation of an ebb shoal on the ocean side. At this time, the ebb shoal had a symmetrical crescent shape. A swash platform was beginning to form in the inlet throat just off the northern spit. A south flood shoal formed in the bay and encompassed the southern remnant shoal. Sand was also growing on the north flood shoal that had attached to the north remnant bay shoal. The main ebb channel

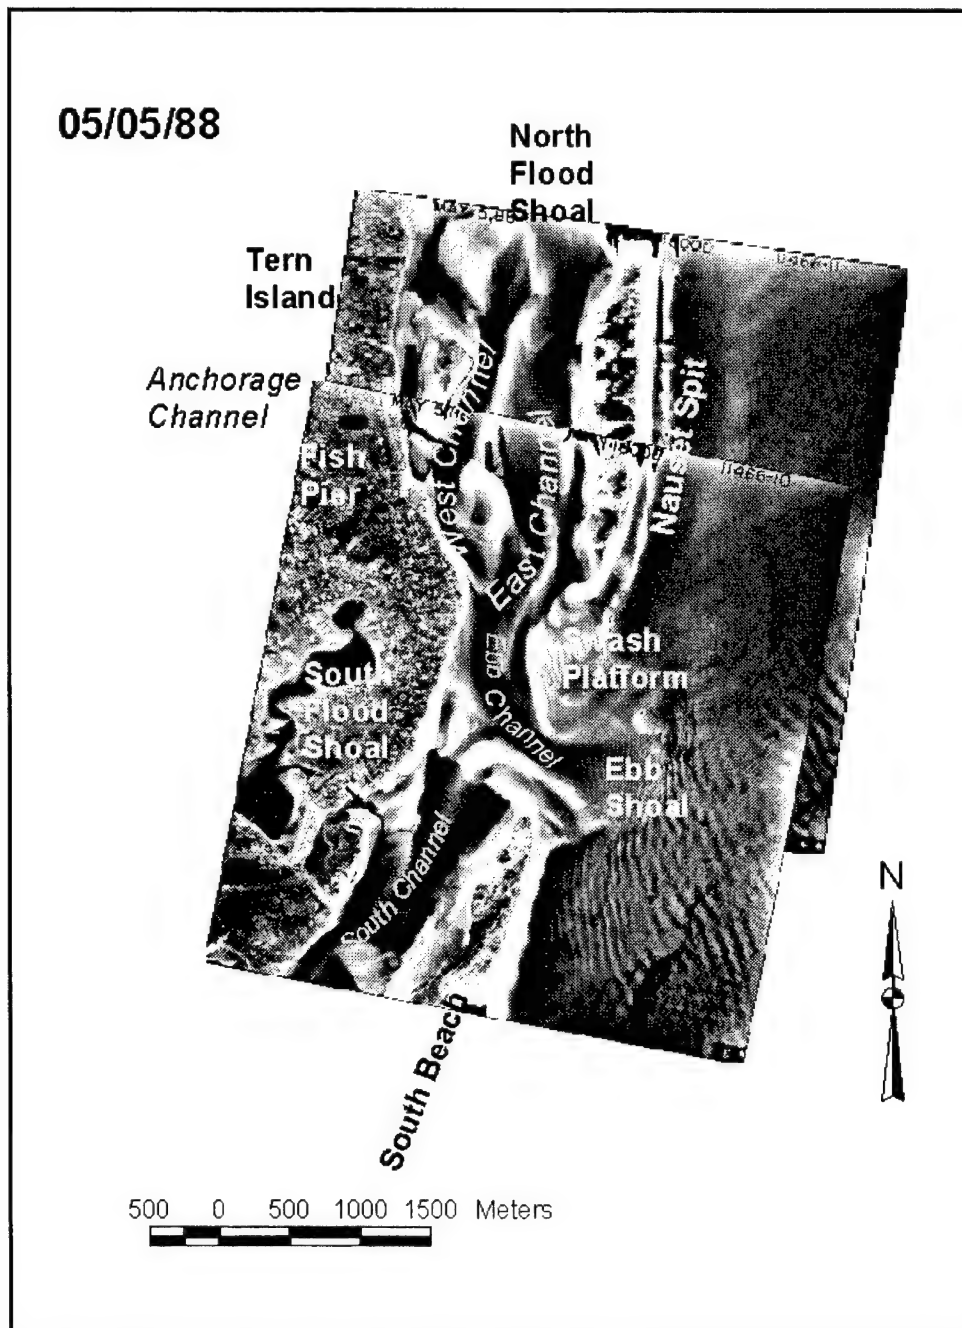
Figure 7. Morphology of Chatham Harbor, 5 May 1988

The north and south beach spits continued to recurve as the inlet throat widened. Figure 7 shows the inlet 17 months after formation on 5 May 1988. The main ebb channel had migrated to the south and the swash platform on the north end of the ebb shoal had enlarged. The north barrier spit had recurved north-westward into the bay. The south spit continued to recurve westward into the bay. The south beach spit had been described as having five cycles of spit evolution between 1987 and 1989, with spit elongation into the bay, narrowing of the spit and breaching of the spit end (Weidman and Ebert 1993). Sand from this breached spit end was incorporated into the complex south flood shoal sand body.

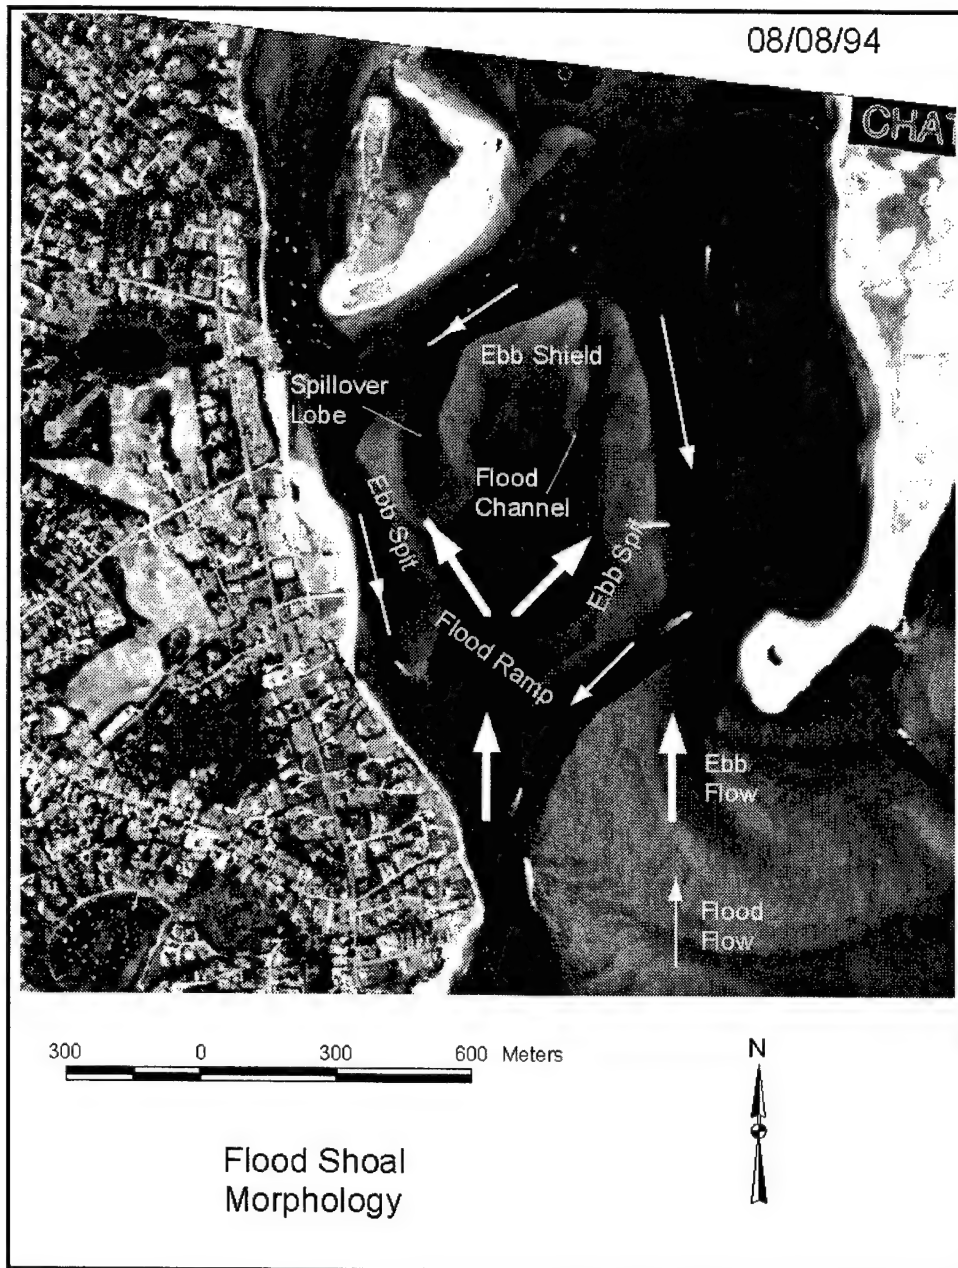
Figure 13. Morphology of the Chatham north flood shoal based on a model of Hayes (1975)

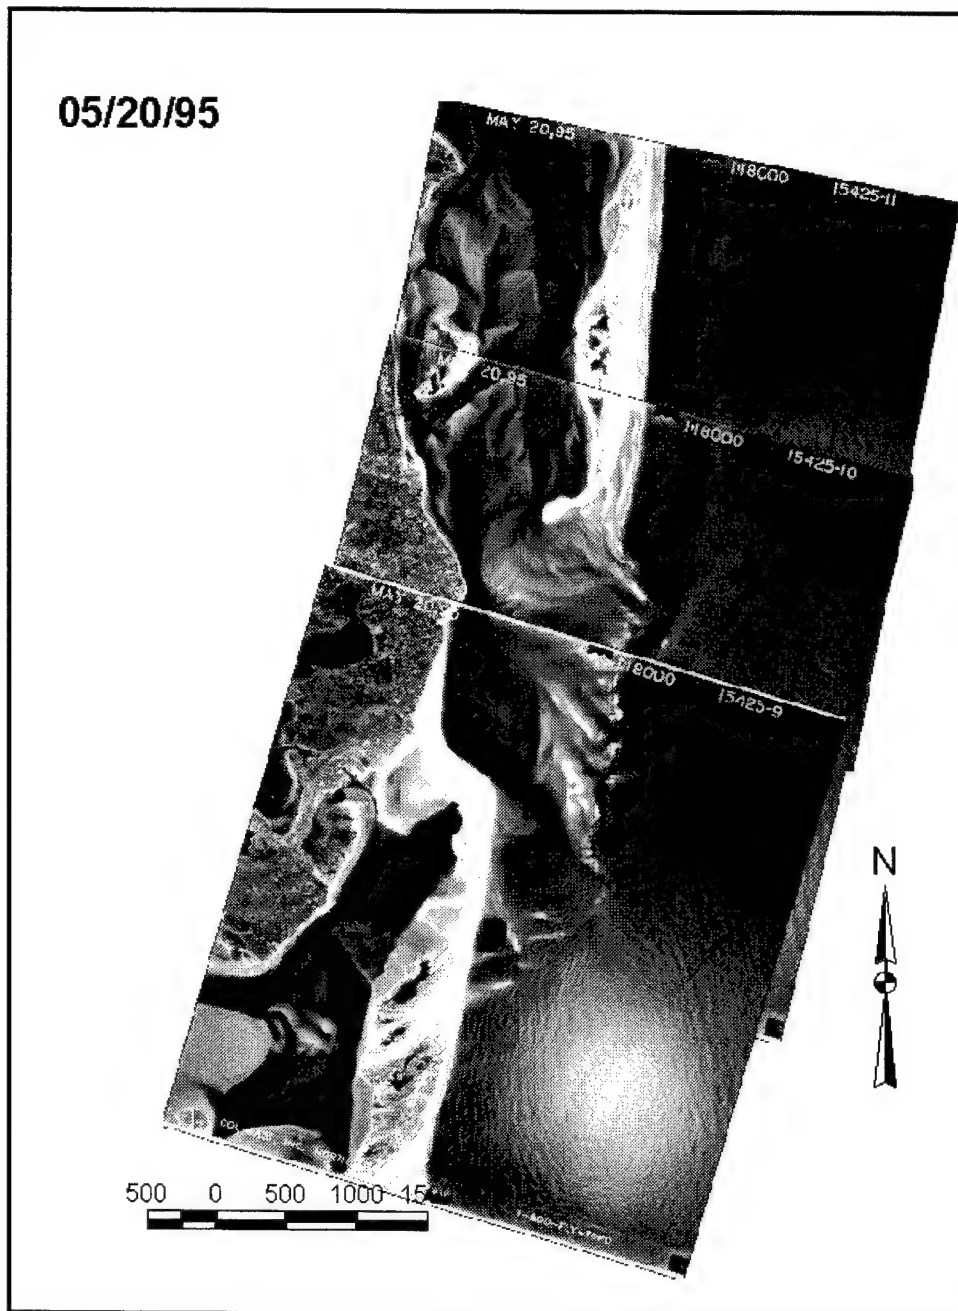
Figure 15. Morphology of Chatham Harbor, 20 May 1995, with two ebb channels

Eight years and five months after the inlet breach, the inlet was approximately 8,500 ft (2,600 m) wide. The main ebb channel had migrated to the extreme south end of the inlet and was against the South Beach shoreline in the 20 May 1995 photographs (Figure 15). A second ebb channel was beginning to form around 1,000 ft (304.8 m) north of the initial breach. The ebb shoal was divided into three parts with a smaller north swash platform, central ebb platform, and a southern ebb platform. The terminal lobe of the ebb channel was south of the north end of South Beach as the shoal took on an extreme asymmetrical shape to the south. The South Beach continued to migrate landward, but did not move further to the

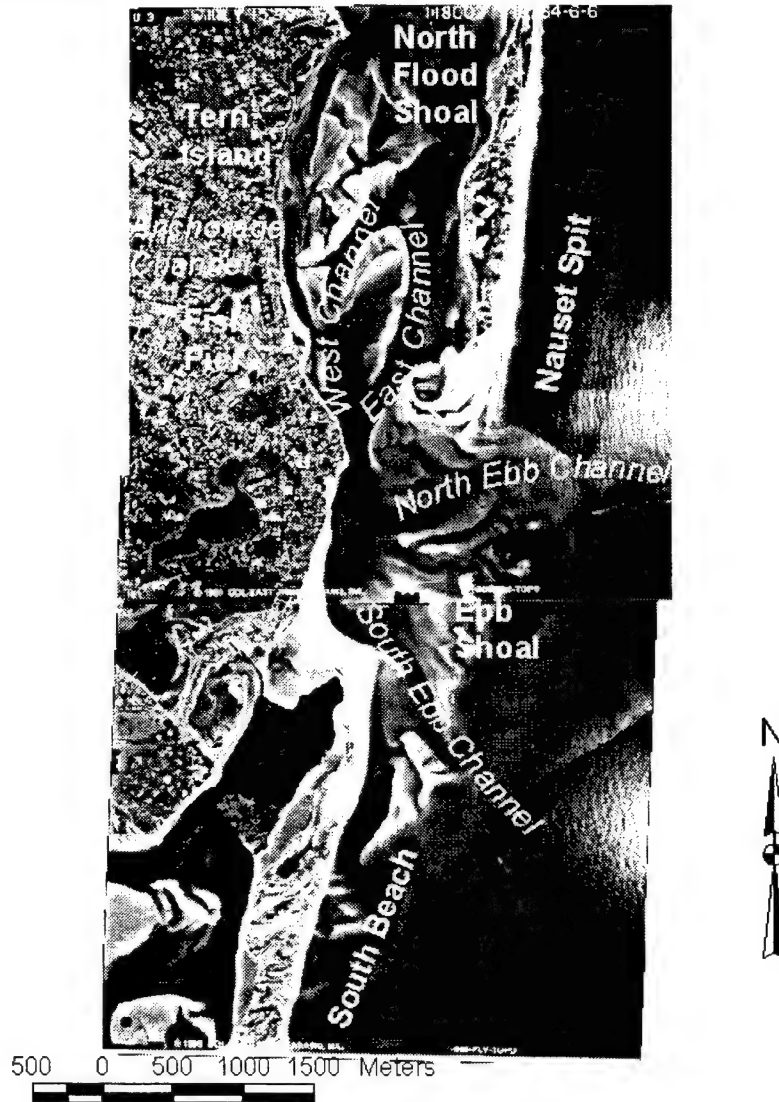
Figure 19. Morphology of Chatham Harbor, 15 July 1999

Twelve years after the initial breach, Chatham Inlet has still retained a highly dynamic morphology. Figure 19 shows the inlet as of 15 July 1999. The linear shoals continue to gain sand on the expanding ebb shoal. With the increasing dominance of the meandering northern ebb channel, the ebb shoal is expanding seaward on the north end. At the same time it is migrating further to the south, creating substantial shoals and making navigation through the southern ebb channel a challenge. A new ebb-orientated spit has formed at the tip of South Beach. The south channel has been pushed against the mainland shore as the ebb

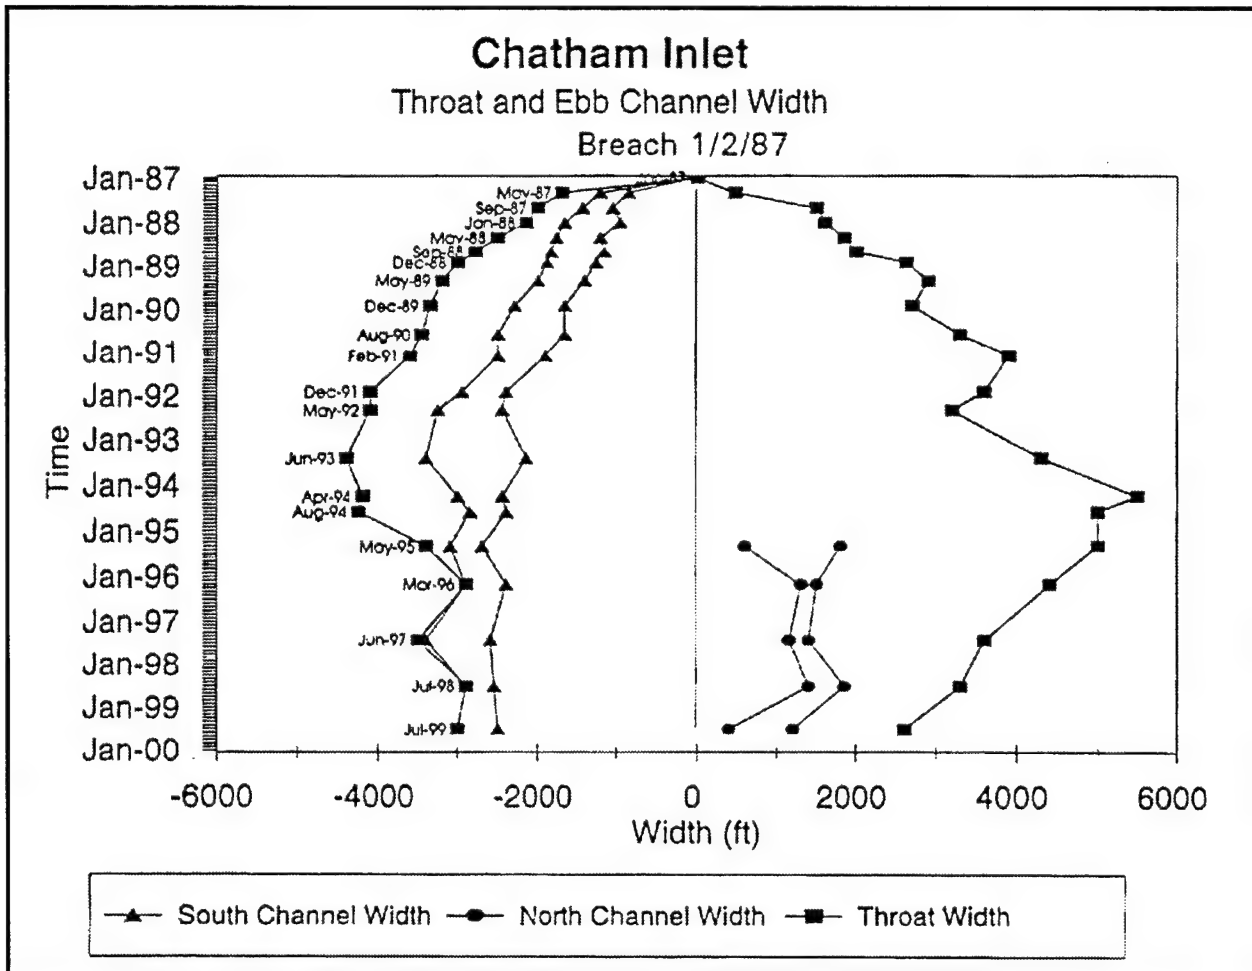
Figure 20. Temporal change in inlet throat width and position of ebb channels with respect to original beach location

Changes to the throat section between the adjacent beaches and the position of the ebb channels was quantified by measuring the distance along a common line drawn along the axis of Nauset Spit between the edge of the north and south spits off of each yearly photo set. The width of the ebb channels was also measured where each side of the channel crosses this reference line. A zero point was taken at the site of the original breach. Figure 20 plots the inlet-throat width and channel positions, which were updated from Liu et al. (1993). The distance between the

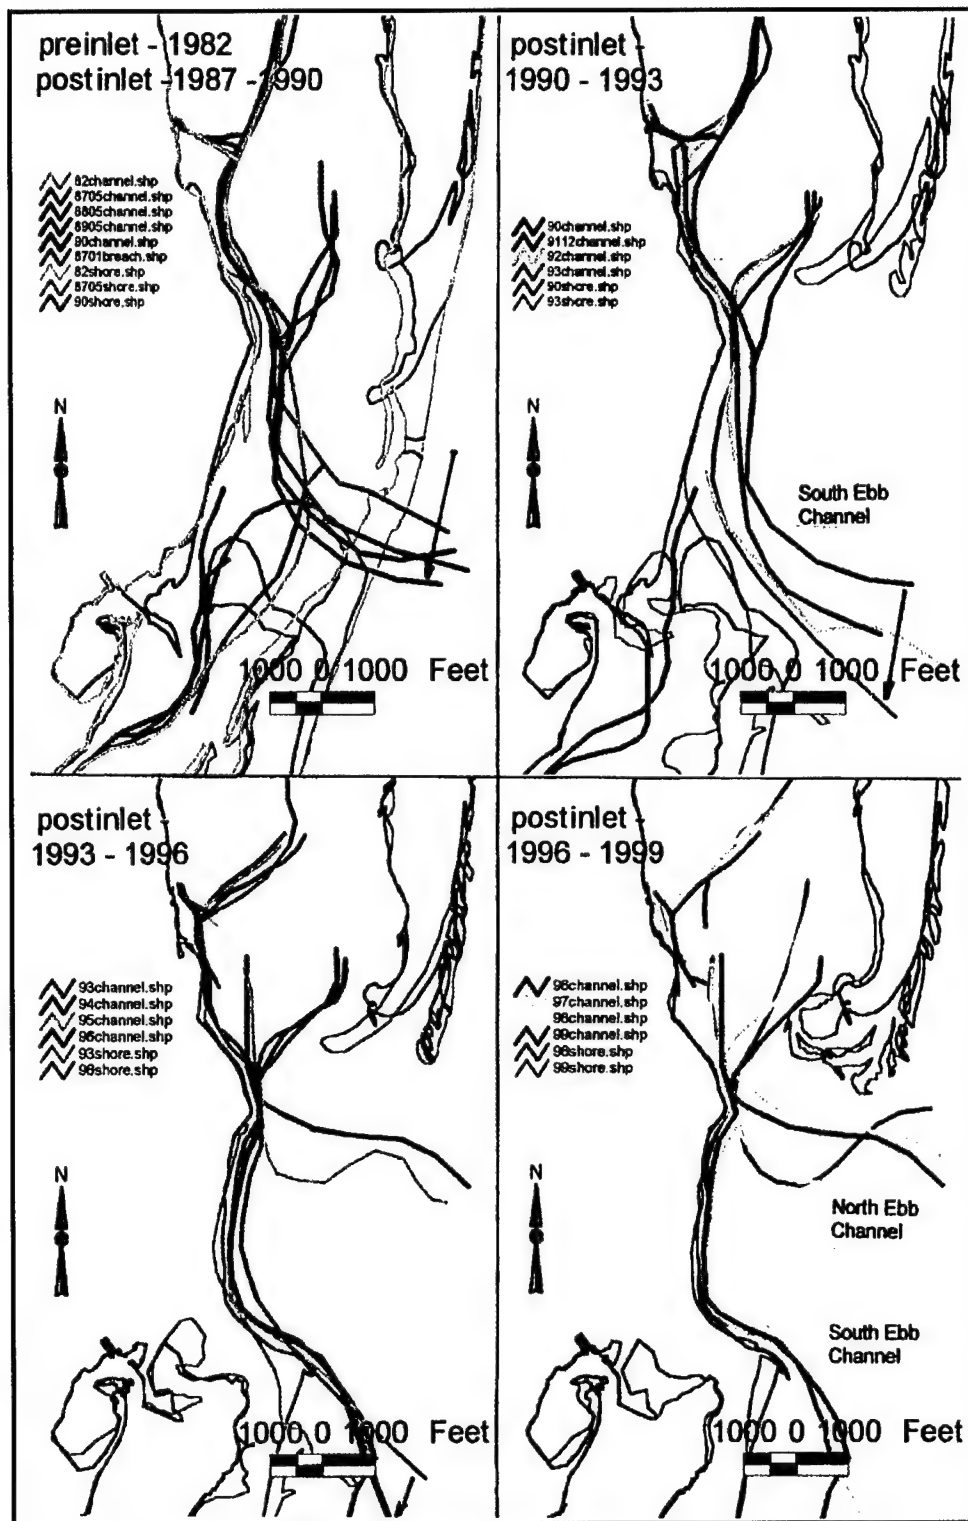
Figure 21. Change map of ebb channel center lines

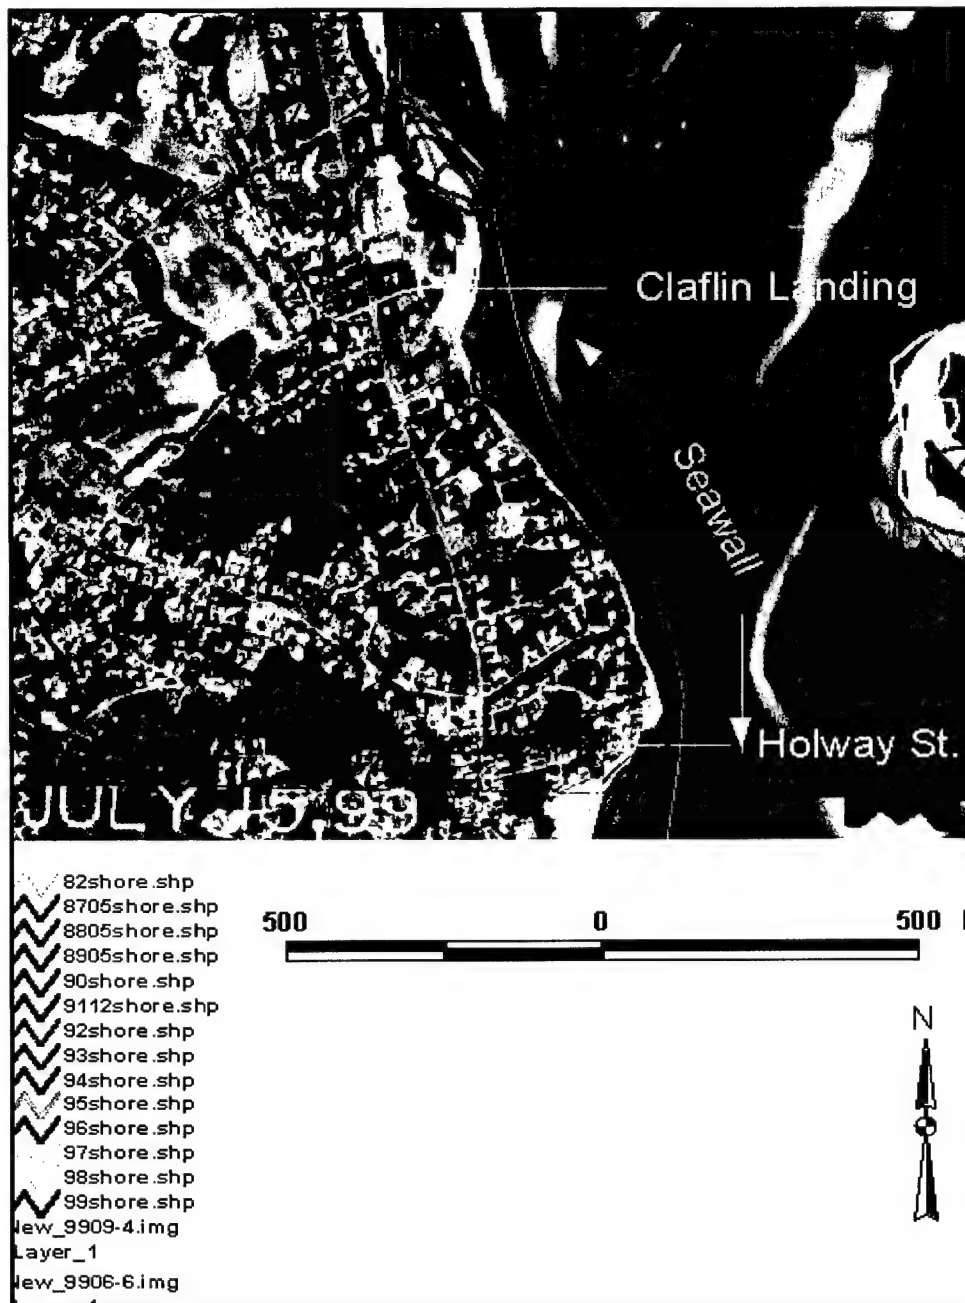
Figure 23. Mainland shoreline change in seawall area (Claflin Landing to Holway Street)

Figure 23 shows the mainland shoreline change from preinlet 1982, where the shoreline was from 100 to 300 ft (30.5 to 91.4 m) further seaward. As the inlet

was opening, after 1987, the shoreline maintained a wide low tide beach along this stretch of shore that formed a point into Chatham Harbor through 1989. As Nauset Spit moved north and west the inlet throat expanded and allowed waves and stronger tidal currents to directly encroach upon this shoreline. A stone revetment was constructed during the winter of 1987-1988 to protect the upland property as the shoreline began to erode almost immediately after the inlet opened and some houses were damaged or completely destroyed. Erosion in front of the structure continued through 1989, and the revetment was enlarged and strengthened between 1989 to 1990 after being overtopped by storm waves. By 1990 the beach

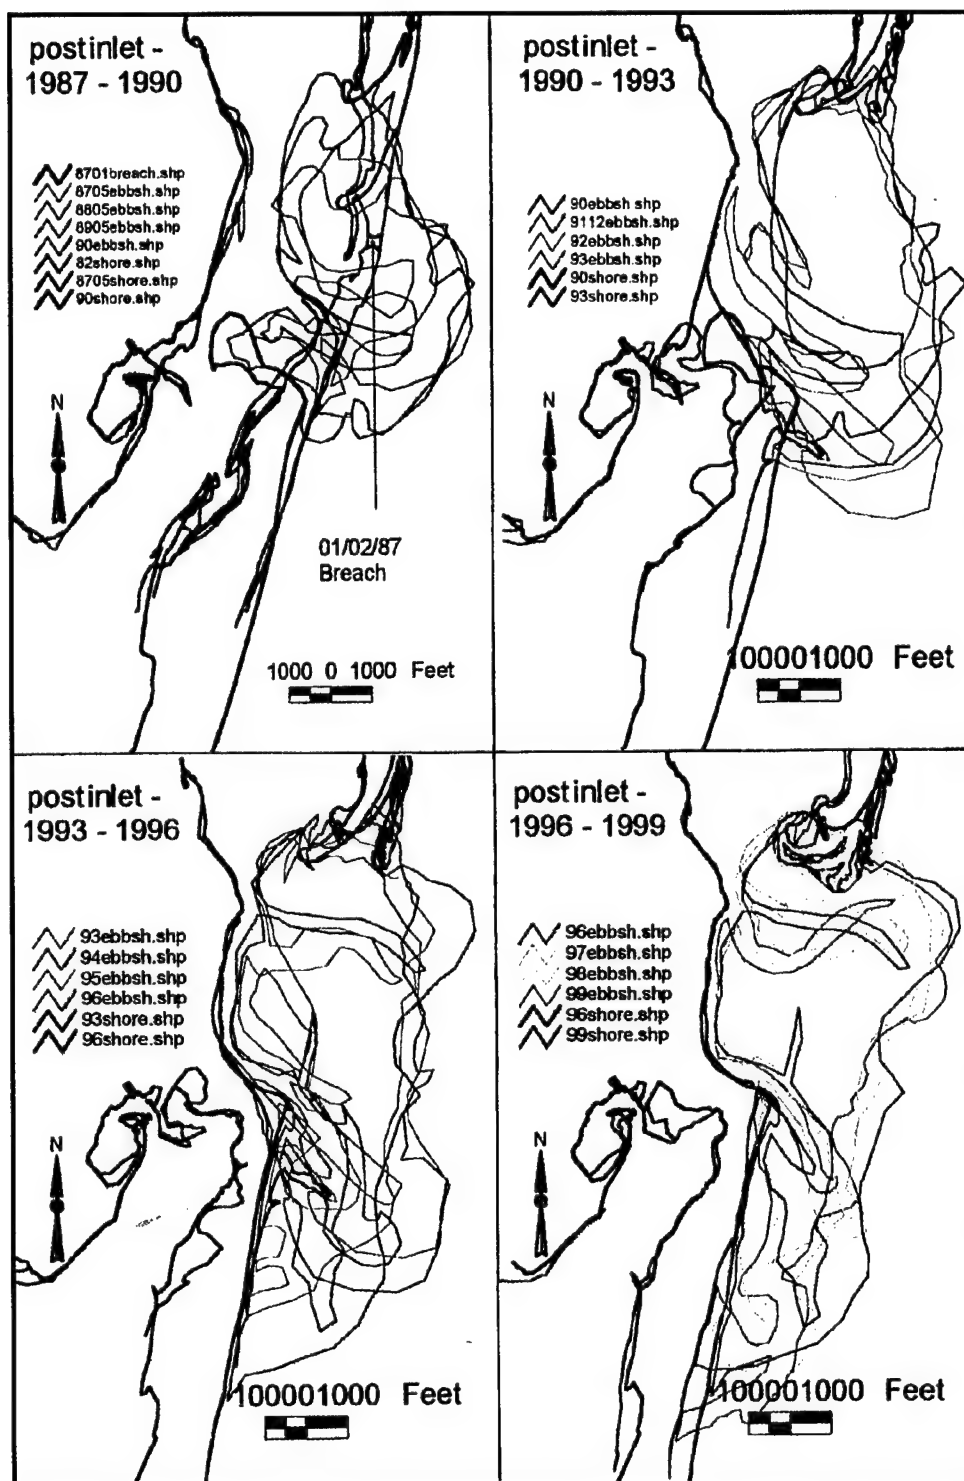
Figure 26. Map of growth in area of ebb shoal/swash platform

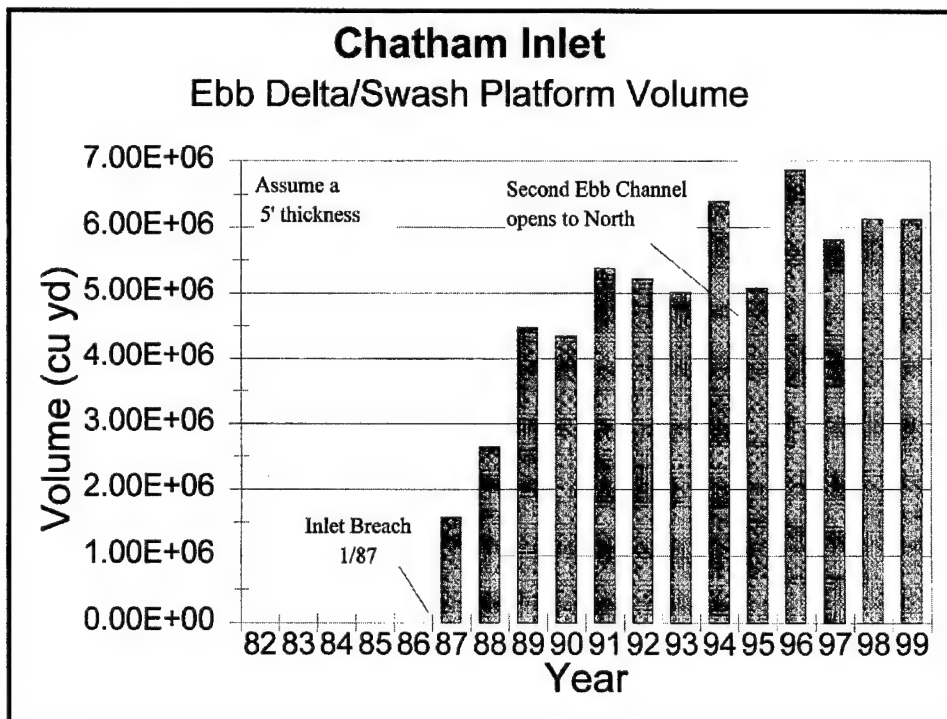
Figure 28. Estimate of volume change in ebb shoal/swash platform

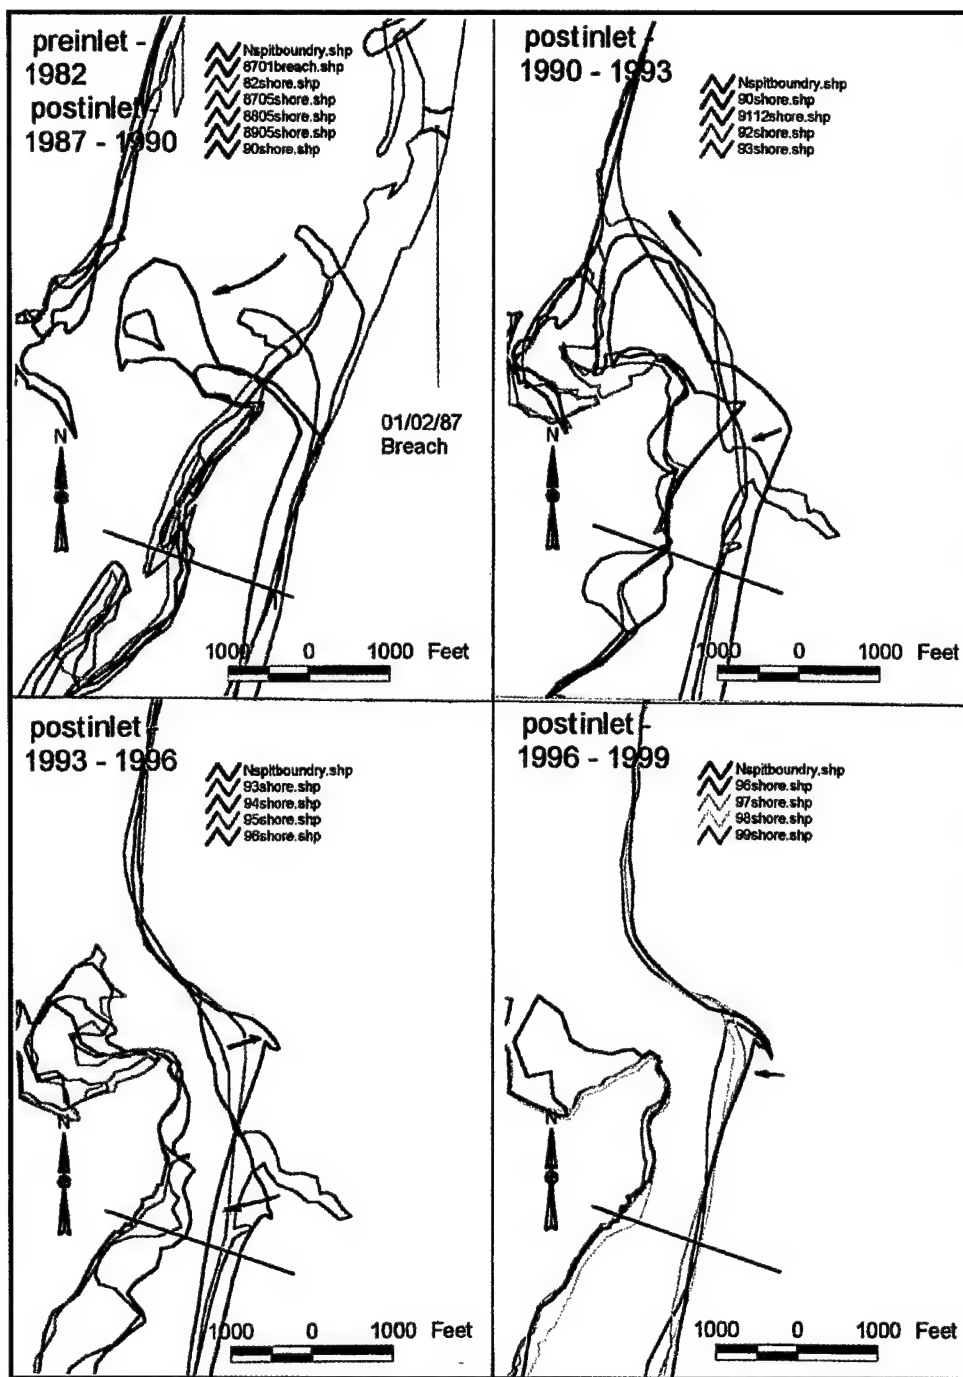
Figure 32. Map of area change to initial recurving south spit and final South Beach land bridge. Line identifies common southern limit of area measurement. Common mainland area boundary used was the 1982 dune/cliff/vegetation line

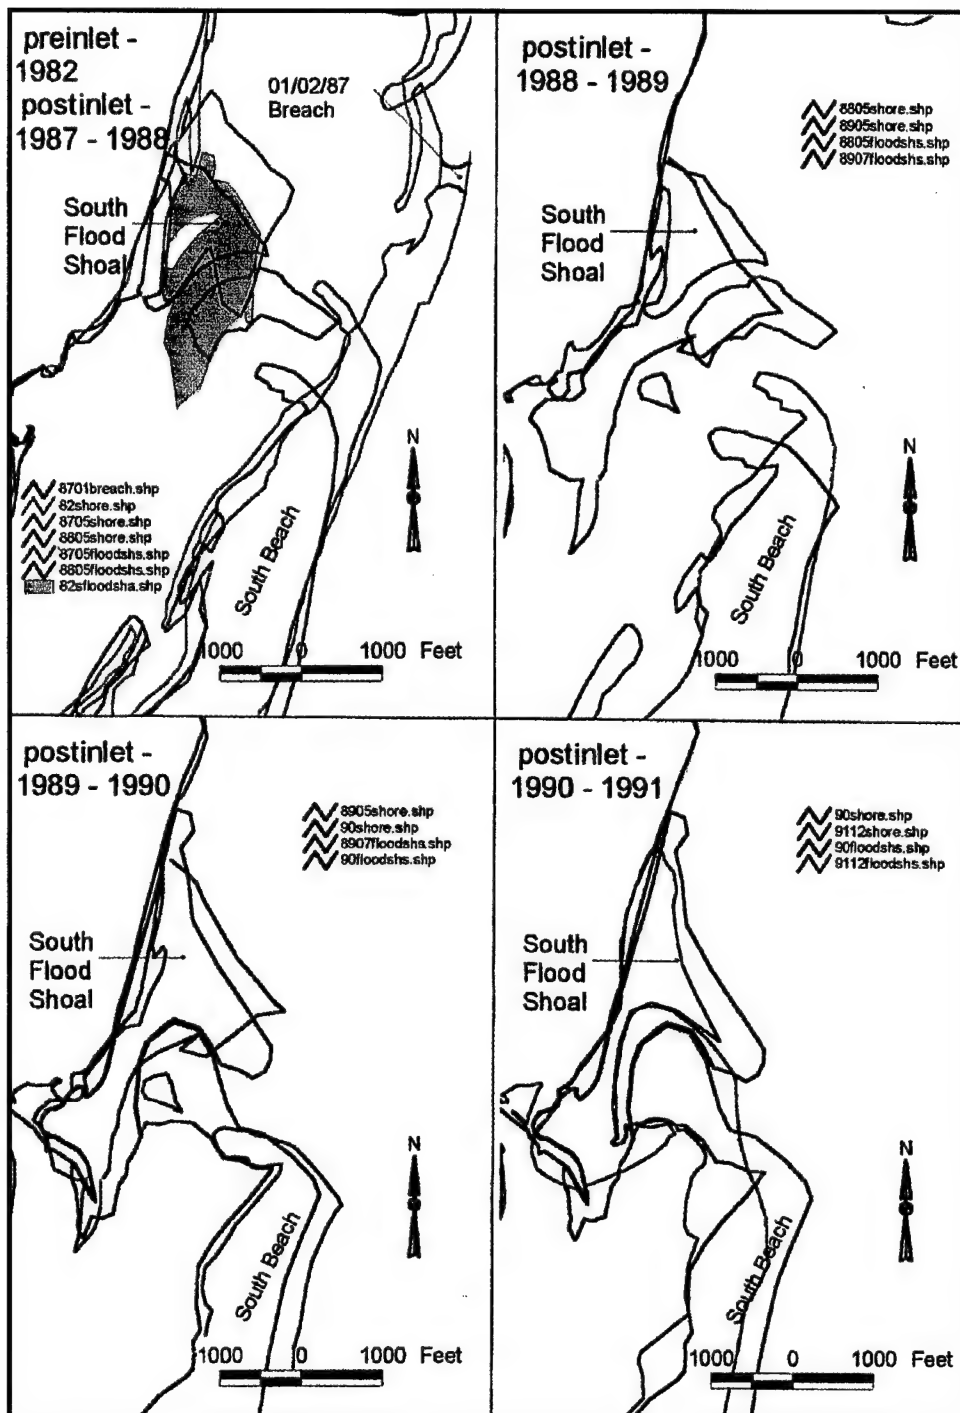
Figure 35. Map of area change to south flood shoal. Solid area shows preinlet remnant shoal that was incorporated into the south flood shoal
